PARK OPERATIONS RECREATION AREAS UNIT UPDATE

Board Operations Committee Meeting
May 29, 2024

Bridget Calvey, Unit Manager – Unit 3

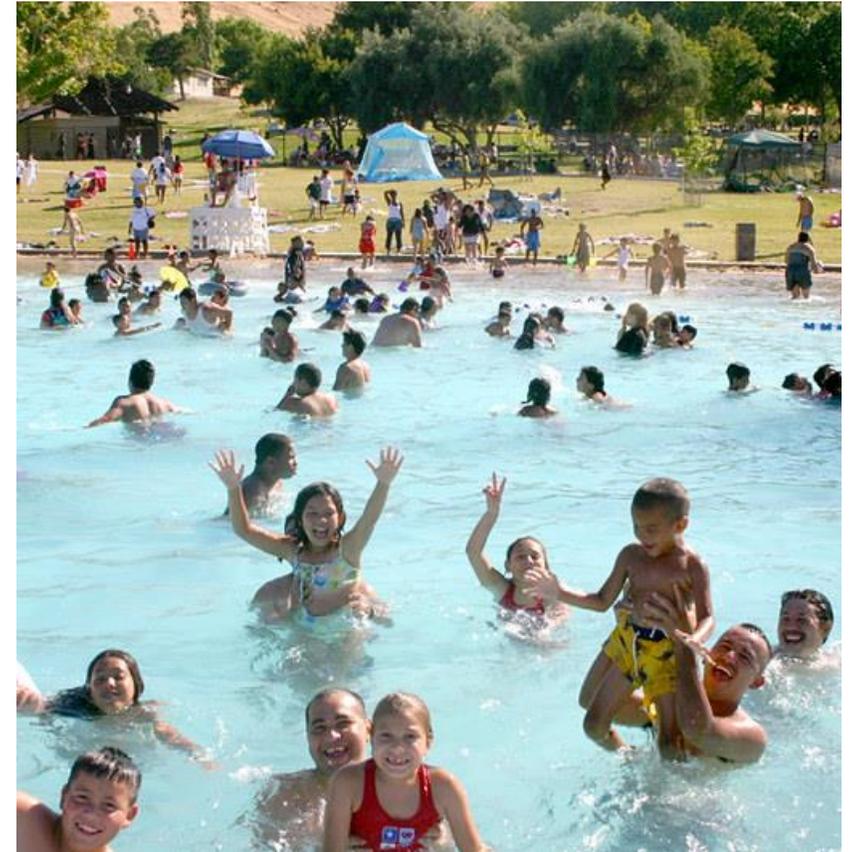
CURRENT STATUS

The plaster floor of the lagoon was resealed in 2020, it began to fail and peel within the first year of the work, which is the reason for the closures during the 2022, 2023, and 2024 swim seasons while designs and projects are approved.

During this closure other maintenance issues have been identified that will need to be addressed, including:

- Leak from back deck into the reservoir
- Expansion joints exposed
- Caulking around deck
- Removal of sand to help with future maintenance

- District Design and Construction (DECO) Capital Projects Manager, Carmen Erasmus is working with a consultant team who are preparing project packages to present to the Board on proposals for the upgrades and current needs for the swim facility.
- The proposals consists of repairing the lagoon, redesigning the turf, restrooms, showers, changing areas, entry kiosk, and surrounding areas for current compliance.
- The project will not only help with maintenance issues but will be a welcomed upgrade for all the communities that frequent this facility.

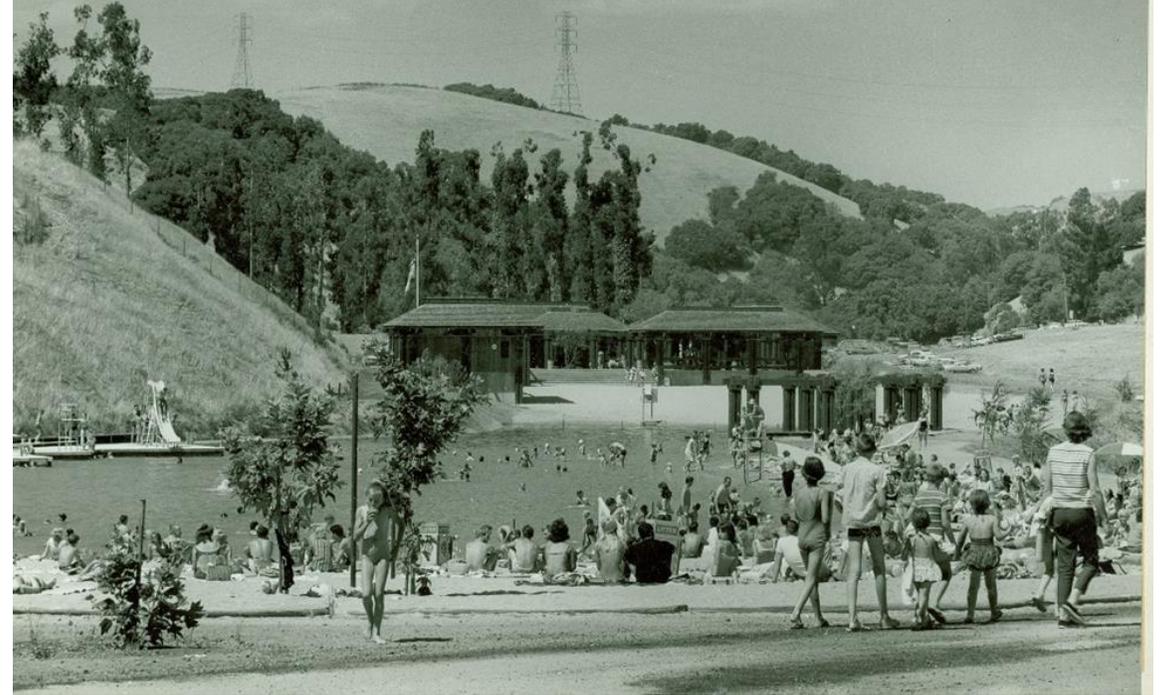
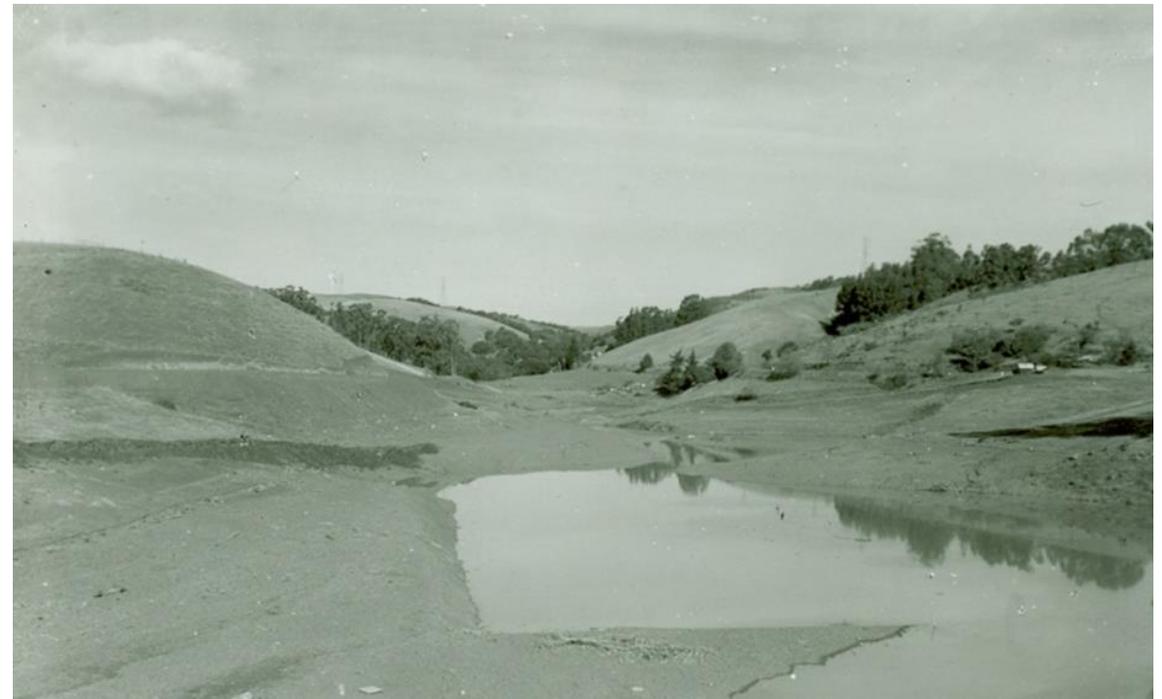
- Cull Canyon prior to construction, 1962
- Cull Canyon lagoon, opened in 1964
- 60 years old this year!
- 2024 capacity is 1,100 people at a time
- Parking lots serve approximately 250 cars
- Swimming occurs April - September
- 2023 attendance was 46,600 visitors!

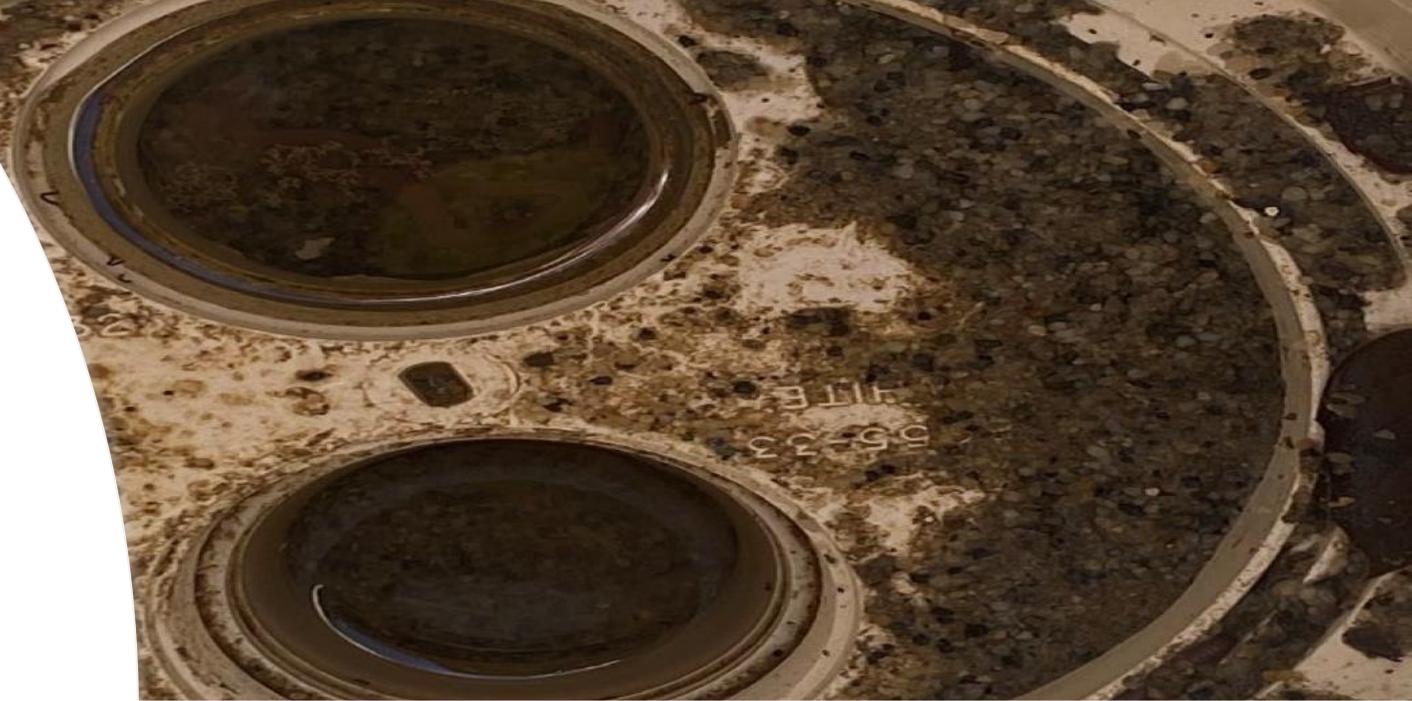
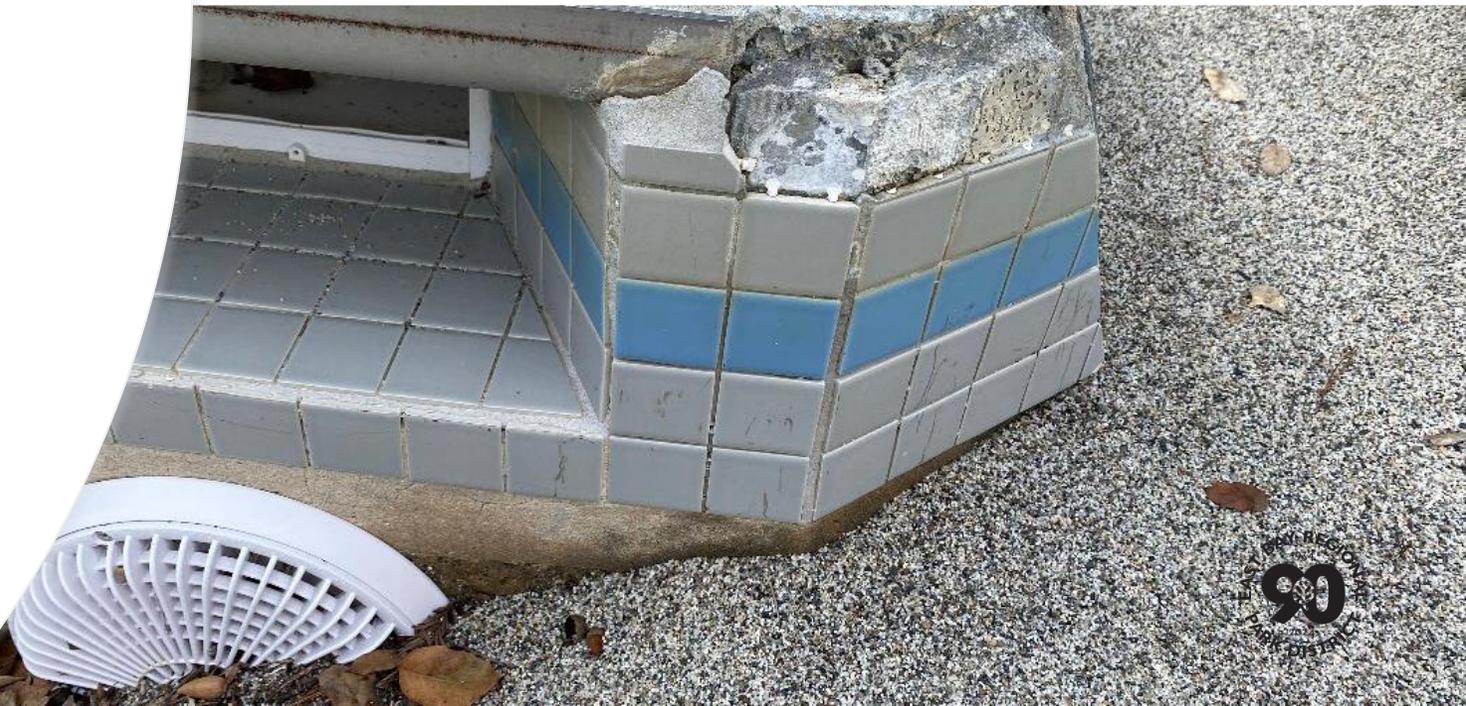
DOCK, EMITTERS, FILTER PLANT, & BASE OF LAGOON

- Aging infrastructure has been causing continual maintenance issues, which interrupts operations.
- Structural Inspection performed in 2022 on the wooden dock, repairs and deck board replacement are needed.

- At one time, the sides and part of the bottom of the lagoon was majority shotcrete with a concrete pad in the middle. Now only about a quarter of the shotcrete still exists and the concrete pad and curbs are in poor condition. The remainder of the shell is sand and dirt.

- The skimmer blocks are also dilapidated and moving, likely causing damage to suction and return lines. Emitter domes are also deteriorating.
- The leak in the filter has been difficult to repair, likely due to the building shifting. Overall, there is a need for more efficient plumbing and upgrades in the filter plant, which will also provide energy savings.

- No major upgrades in the last 20+ years, besides media replacement in 2023 and ongoing minor repairs.

Cull Canyon should receive a complete assessment and likely renovation to help with daily operations and to become a more sustainable facility in the 21st century.

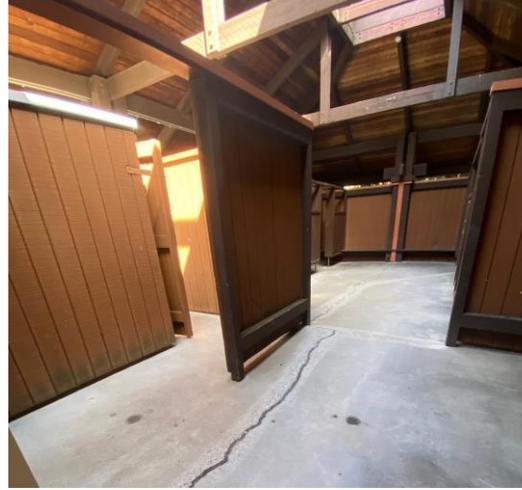
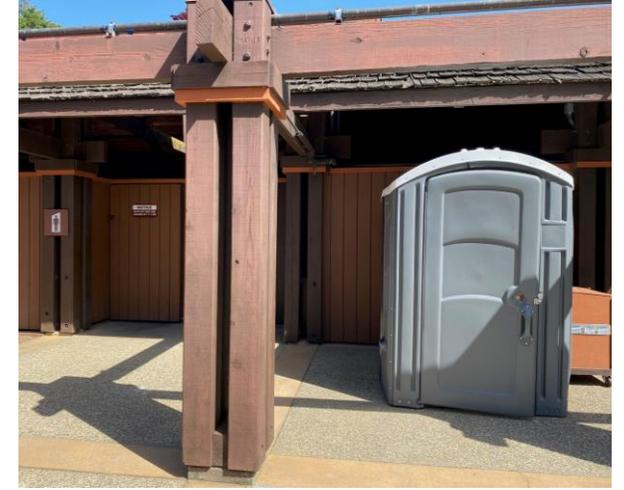
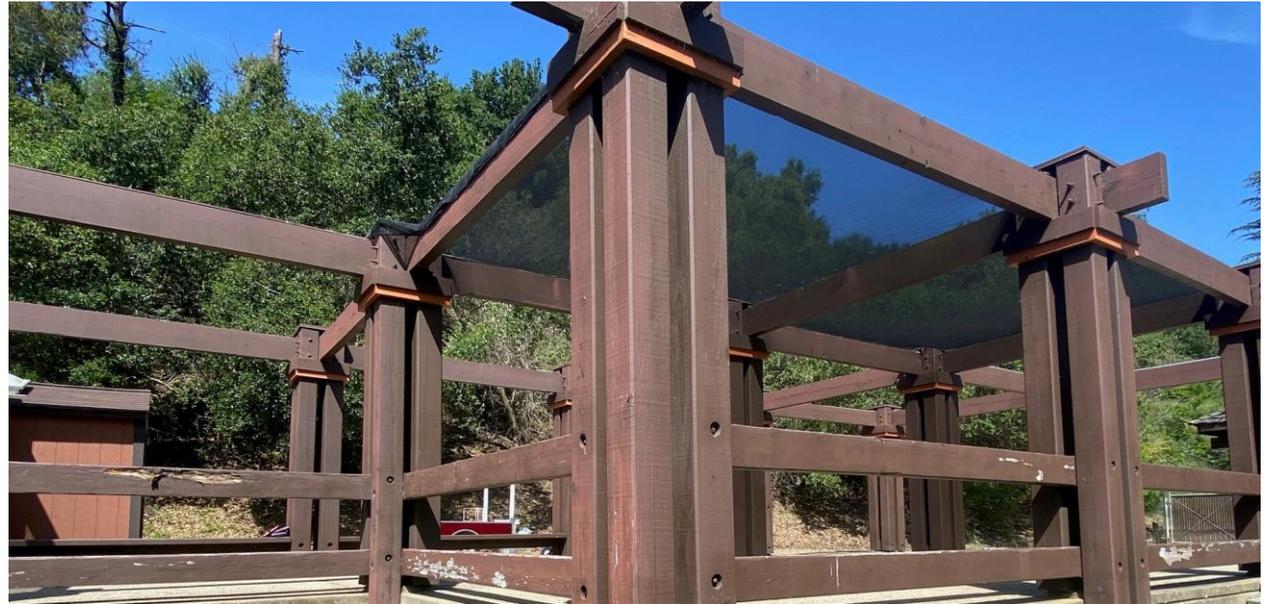
COURTYARD FACILITIES

Northern end of the lagoon is where the entrance, kiosk, main restrooms, changing rooms, & lifeguard building are located. There is only one portable ADA chemical toilet, but no ADA changing areas.

The restrooms and changing areas should be upgraded to meet current standards and a non-gendered restroom should also be added. The women's restroom currently has cracking in the floor showing building movement.

There are seating & picnic tables under a wooden shade structure. The wooden structures need quite a bit of repair and painting, last quote was over \$500,000.

Drainage systems throughout the area need to be assessed and reoriented to meet new standards and capacity.

SOUTHERN END

There are no plumbed facilities, only 2 ADA chemical toilets. There is existing plumbing infrastructure that could be utilized.

The filter plant building is also at the back of this area.

Park Staff is doing an excellent job at monitoring maintenance issues and reporting them. A DECO Services Request has been submitted to address current issues. In 2023, major maintenance was done on the filter plant which will support pump and filtration operations, but there is no shortage of other items to be addressed.

Recommendation

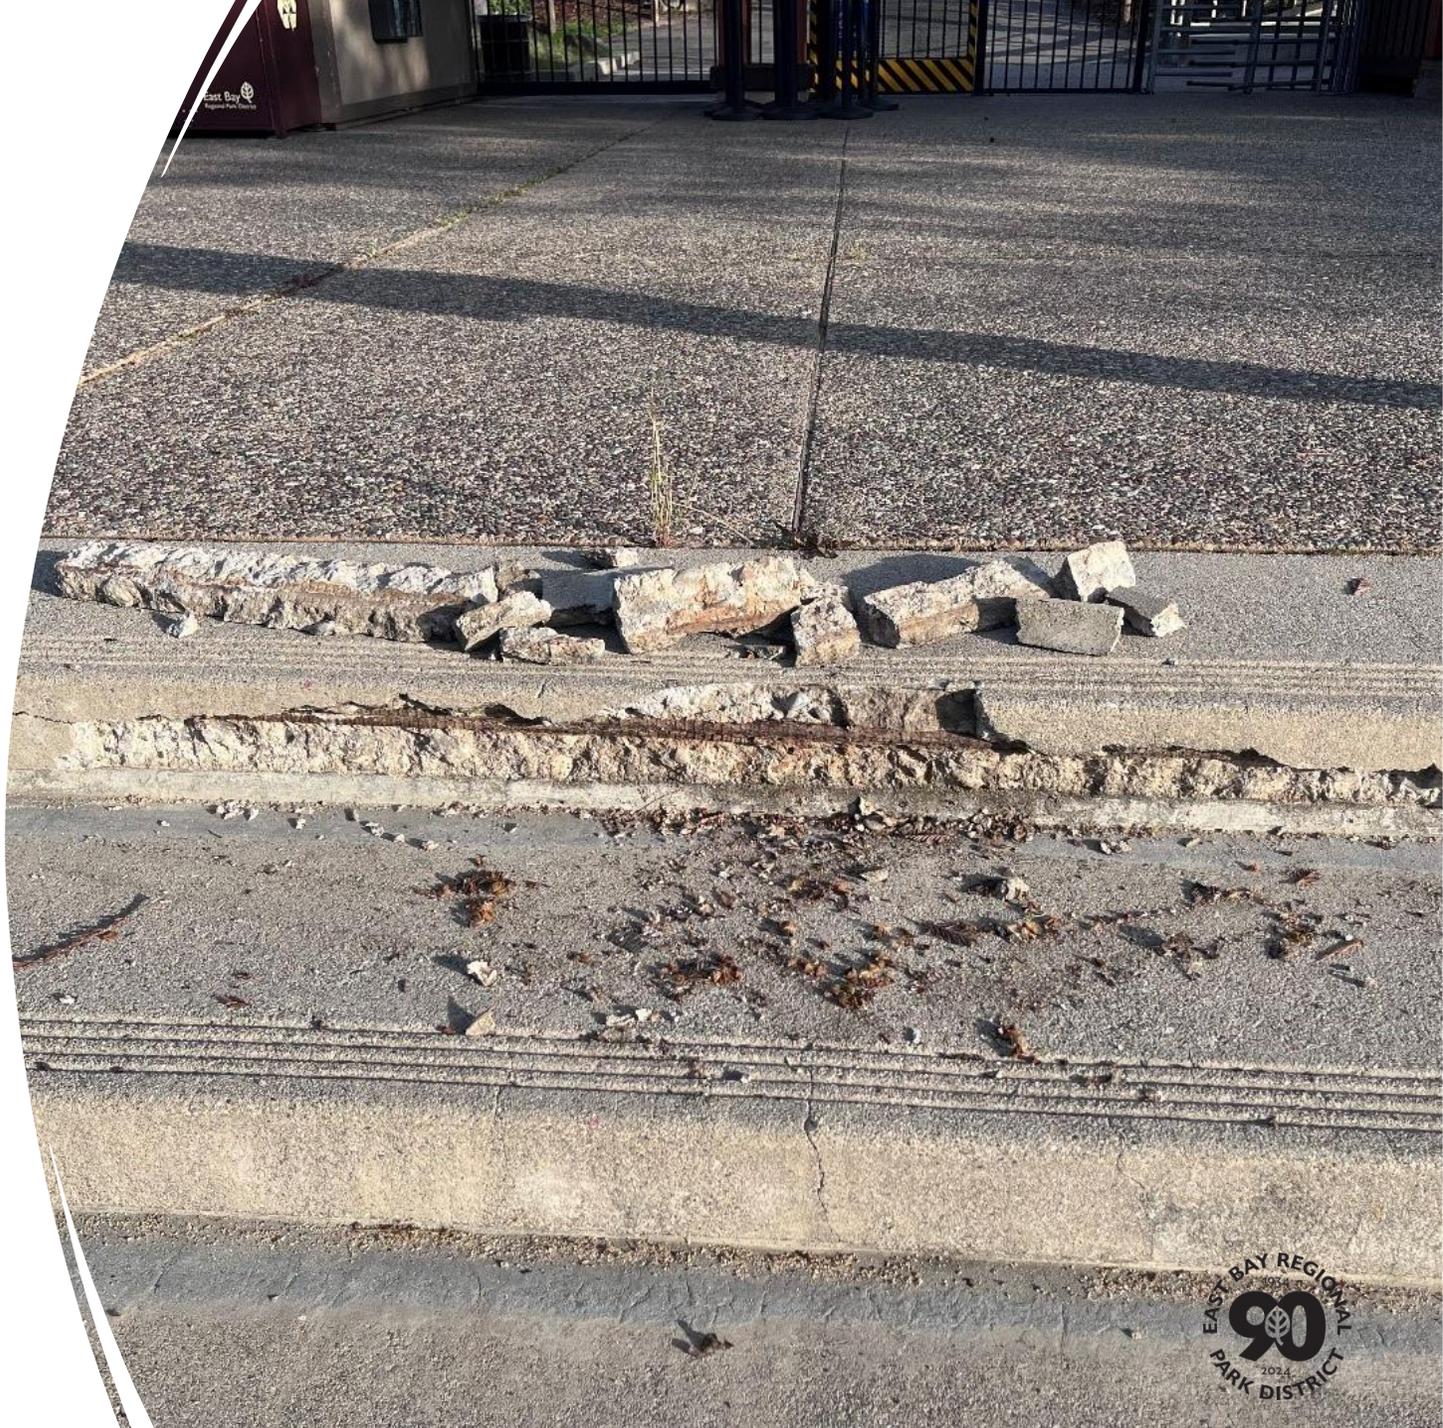
STATUS

- Aging infrastructure is leading to ongoing maintenance issues.
- The main stairs leading to the swim lagoon are deteriorating. A temporary fix was completed in April 2024, and a contract for full replacement is in process.
- There was a DECO request to assess the complete facility and bring it up to current standards and needs.
- Restrooms are located outside the complex, which is hard to manage while the public needs to go in and out of the complex to use. There is one pit toilet located on the far end of the complex.
- Buildings need repairs and painting.
- No power at the entry parking lot kiosk, cash only.
- No major upgrades in the last 20+ years, besides media replacement in 2023, pump repair in 2010, & ongoing minor repairs.

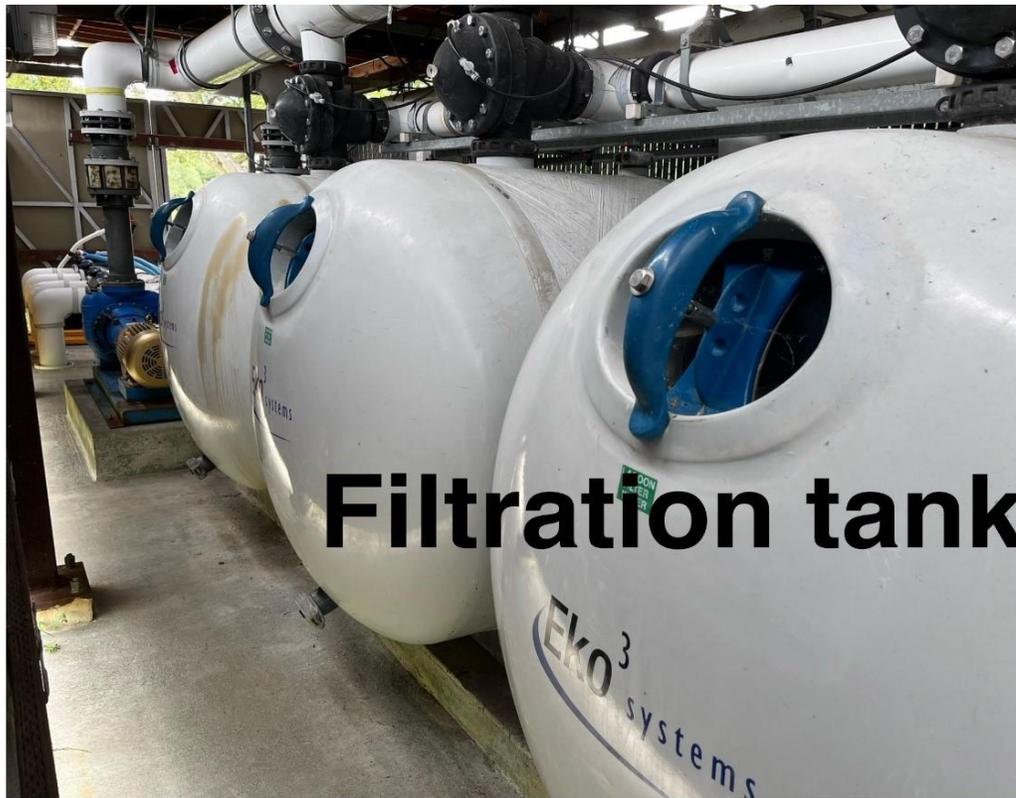
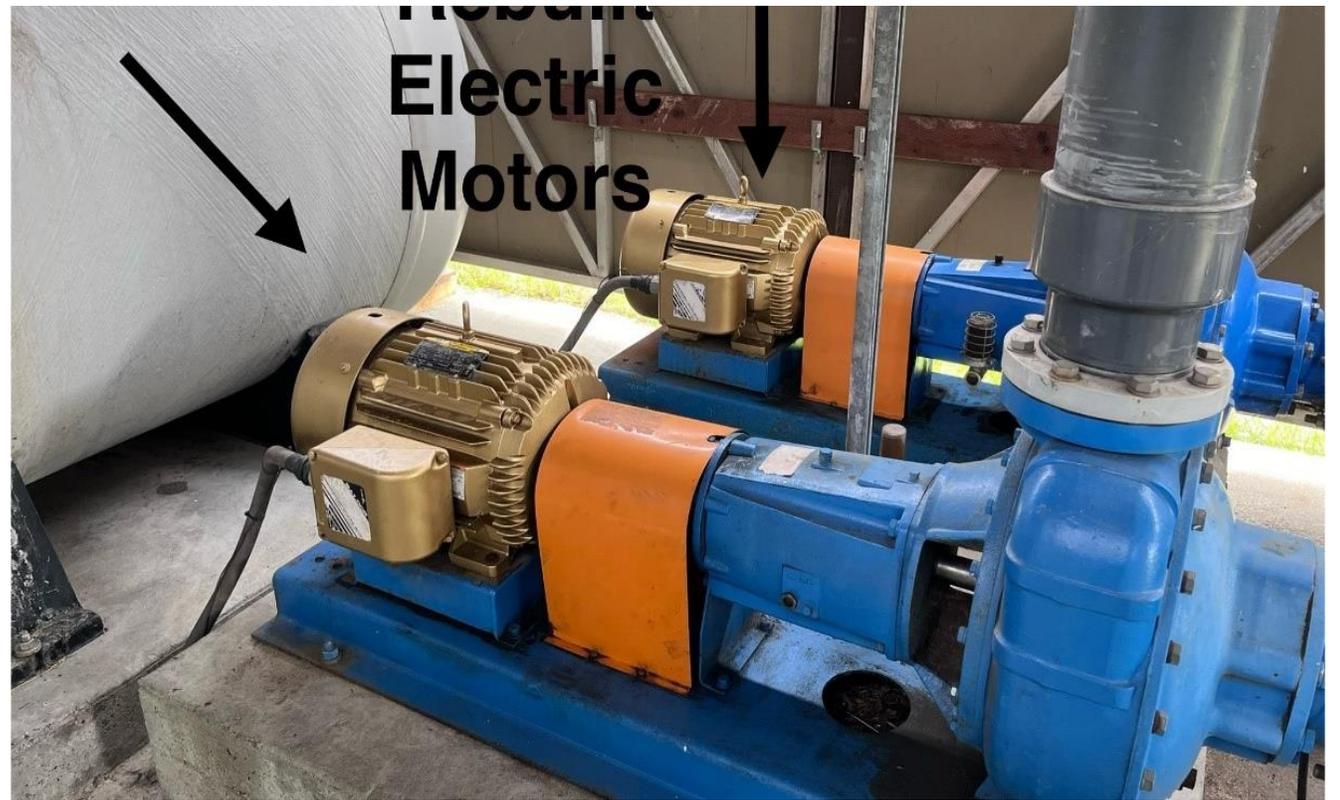
DON CASTRO FILTRATION TANKS

- 2023 filtration system was overhauled
- New filtration media and rebuilt electric pump motors.
- First major service since it's installation in 2010

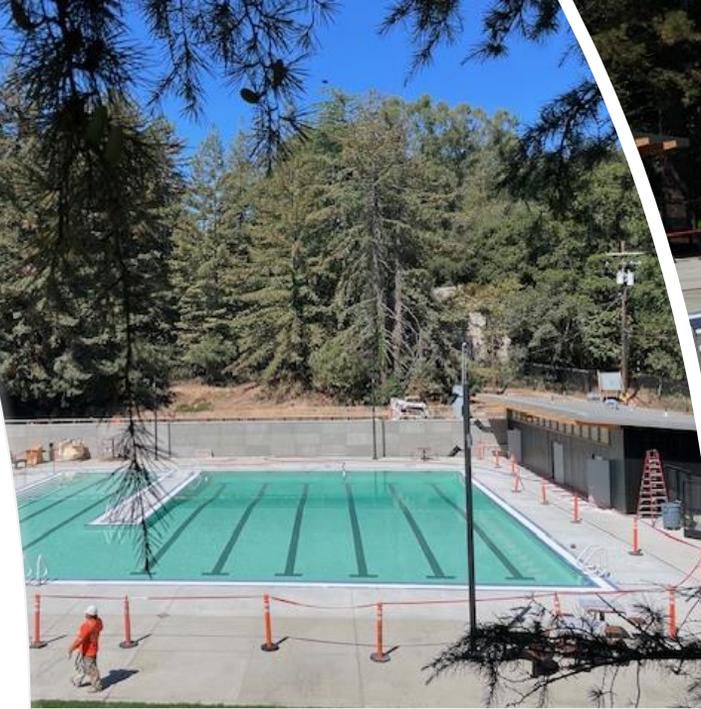
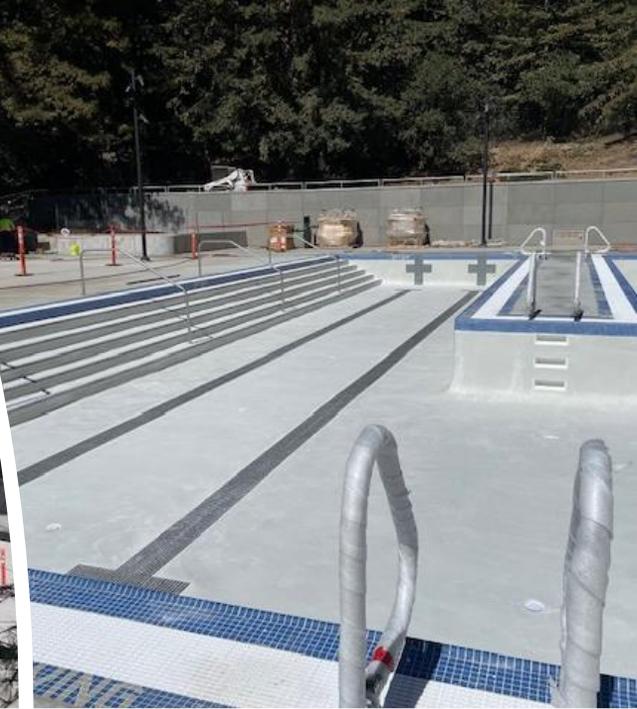
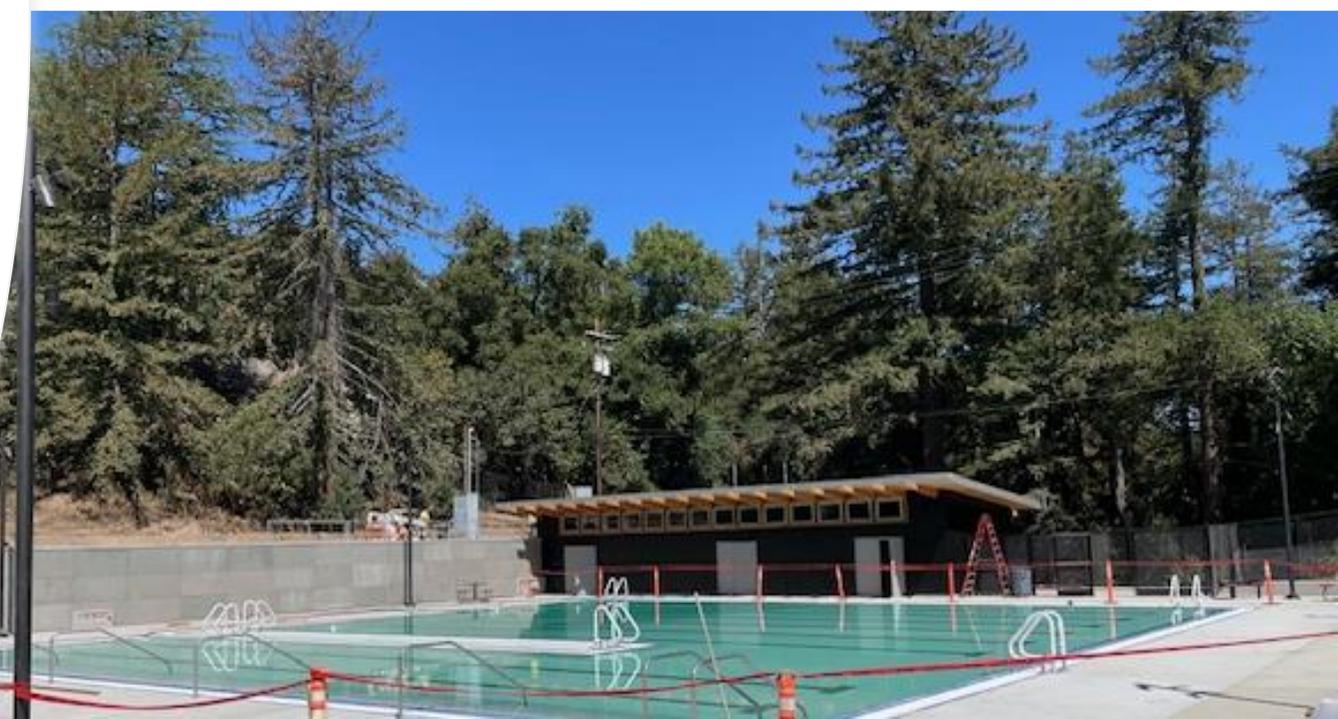
STATUS UPDATE

Job order contracts (JOC) are in place for several other infrastructure upgrades to maintain newly renovated pool complex.

- Work to begin in May 2024
- Backflow preventor will be installed at main entrance to comply with EBMUD.
- Booster pump will also be installed to help maintain water pressure in the park and at the park residence.
- Backwash leach field will be completely rebuilt, including a retaining wall. This is located adjacent to the upper lawn restrooms. When the pool system runs in backwash mode to clean out the sand filters, thousands of gallons of water move through the sand filters to the backwash tank and from the tank to the backwash leach field.
