Harmful Algal Blooms and Lake Management

East Bay Regional Park District

Natural and Cultural Resources Committee

February 13, 2024

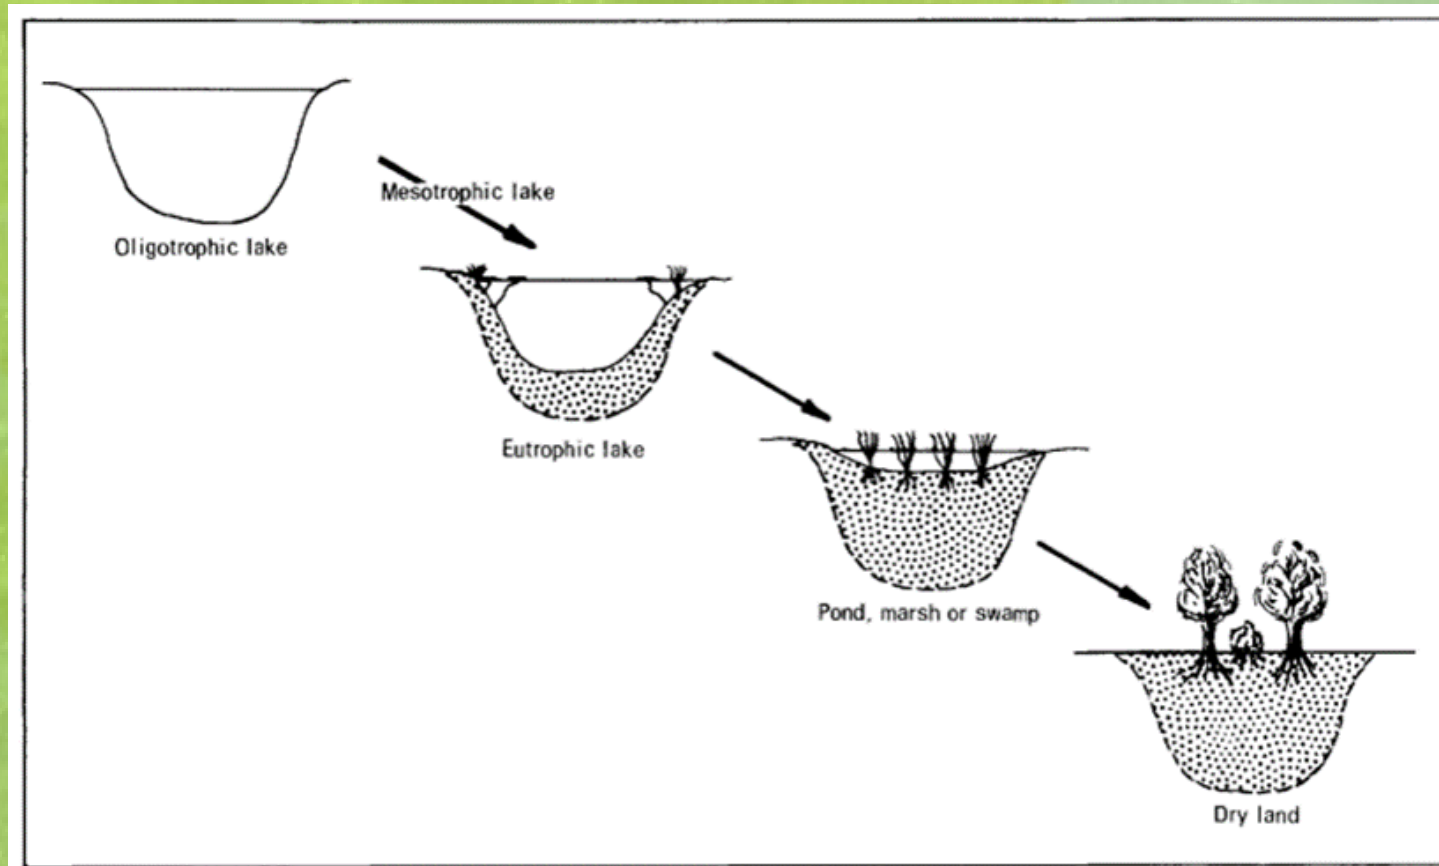
Figure 2. Eutrophication--the process of aging by ecological succession.

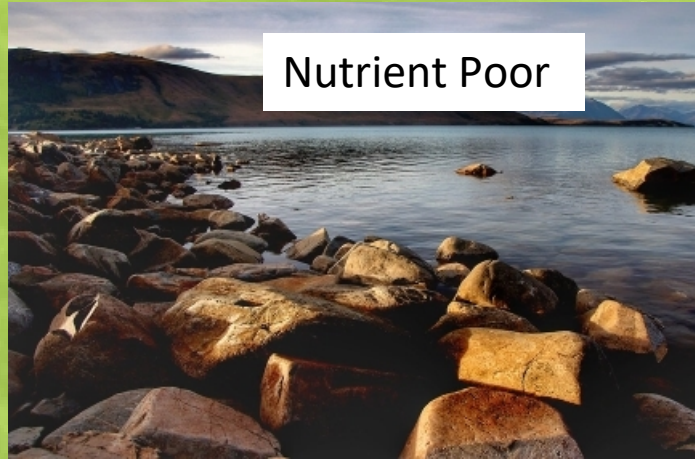
Nutrient Poor

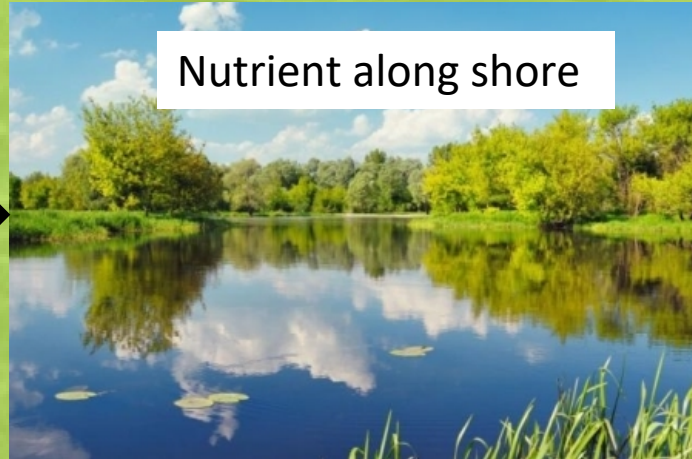
Nutrient along shore

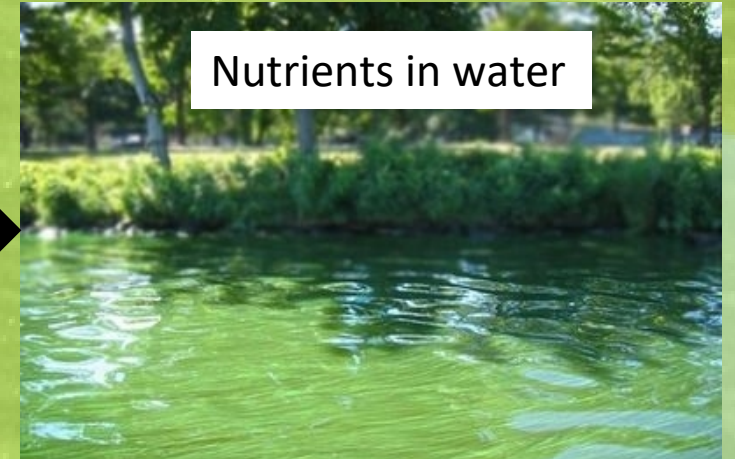
Nutrients in water

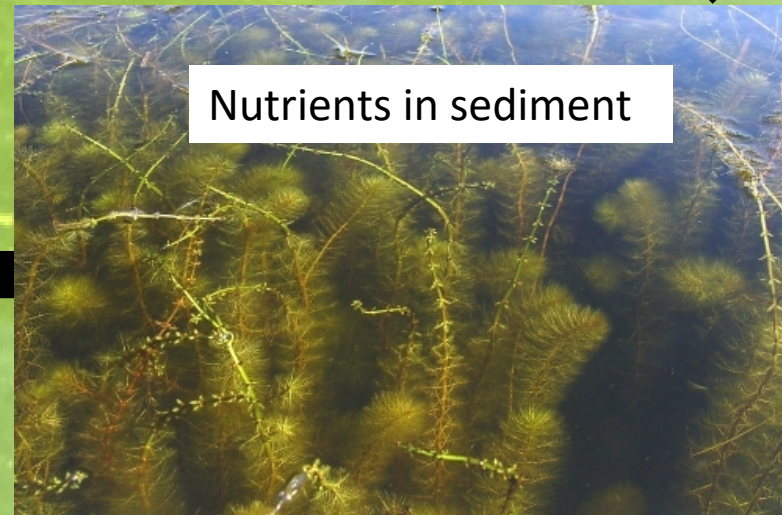
Nutrients in sediment

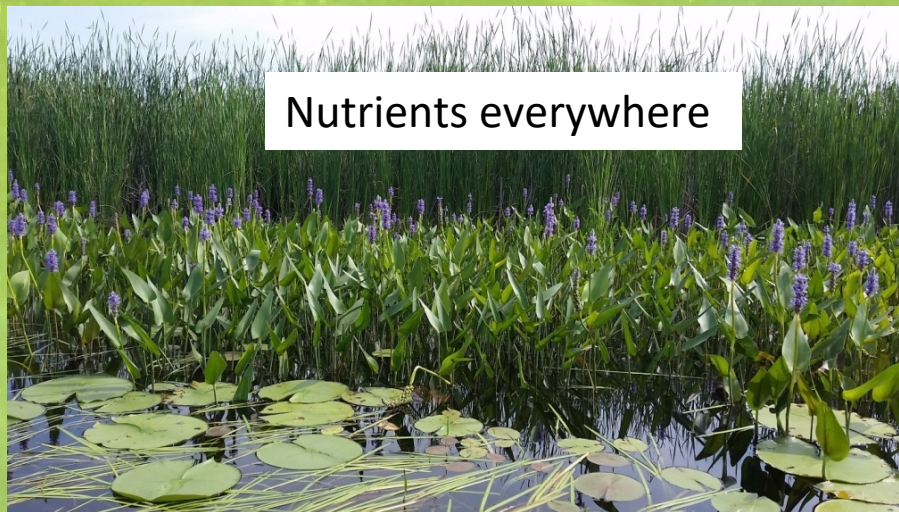
Nutrients everywhere

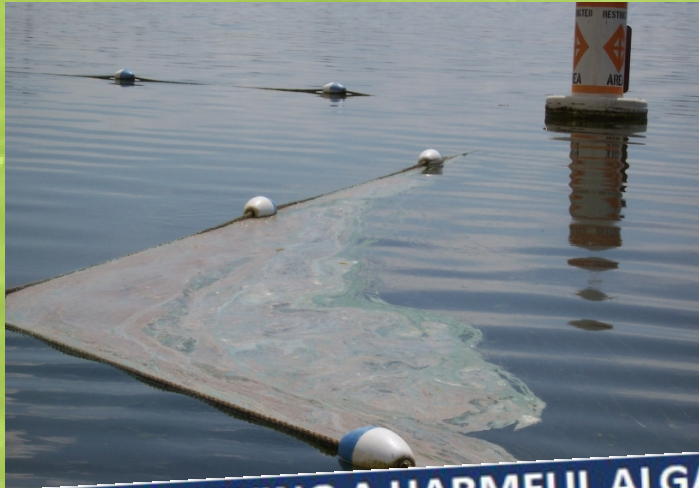
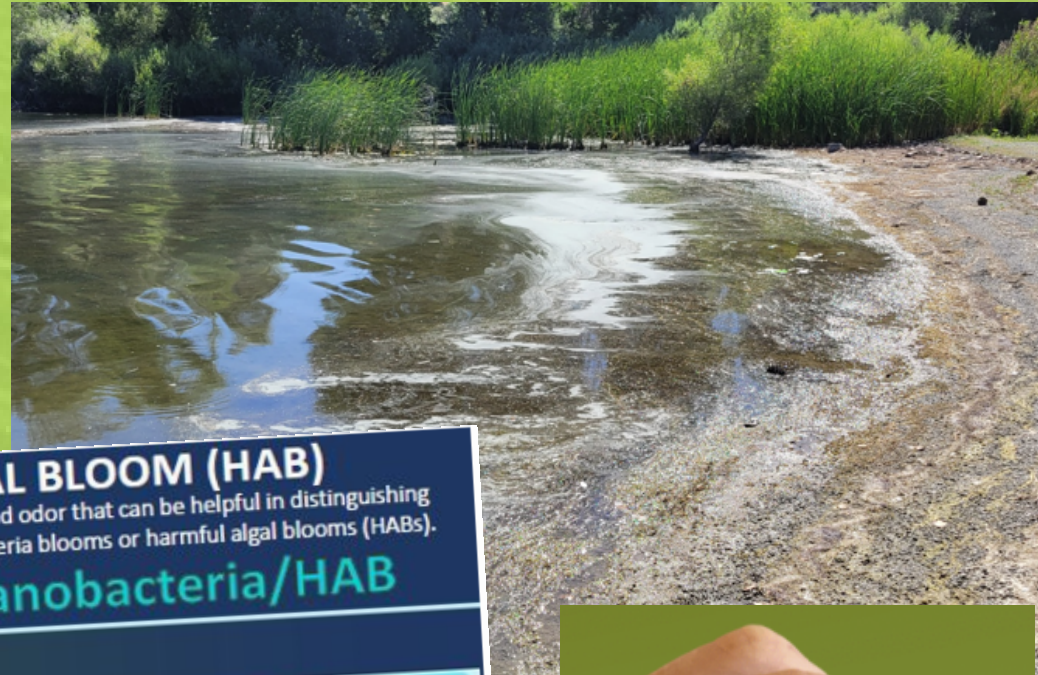
- The water management team runs the HABs monitoring program
- Visual monitoring is conducted weekly from April through October and twice monthly from November through March
- Structures and downwind areas can accumulate cyanobacteria and scums
- Cyanobacteria presence can vary throughout the day
- Samples are collected from the worst areas

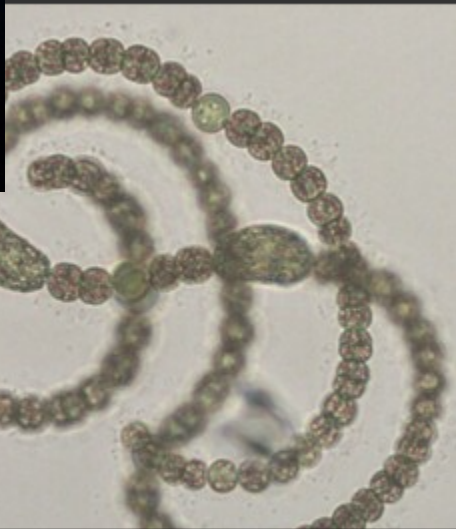
Dolichospermum flos-aquae

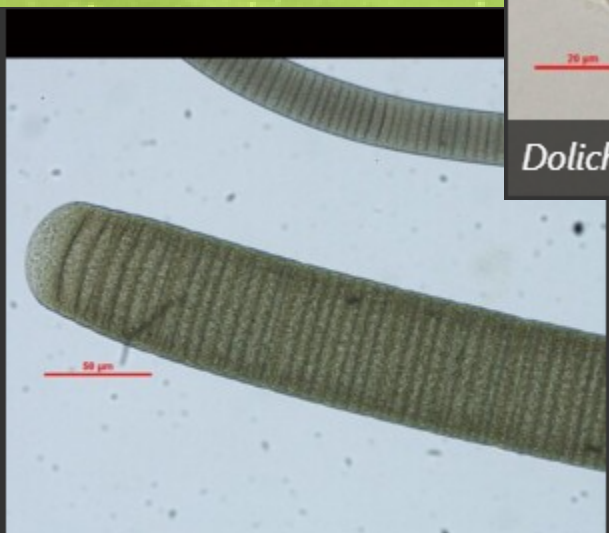
Oscillatoria princeps

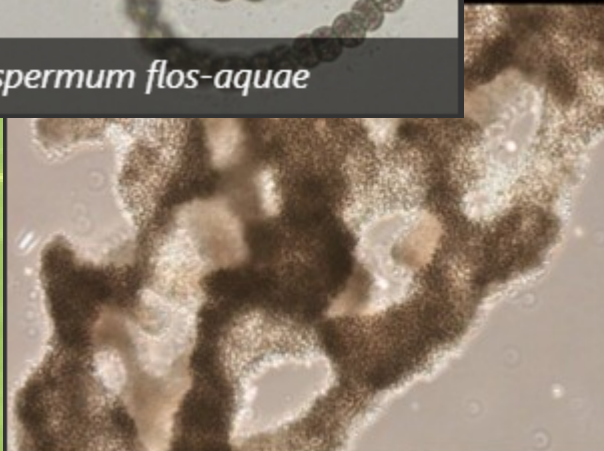
Microcystis aeruginosa

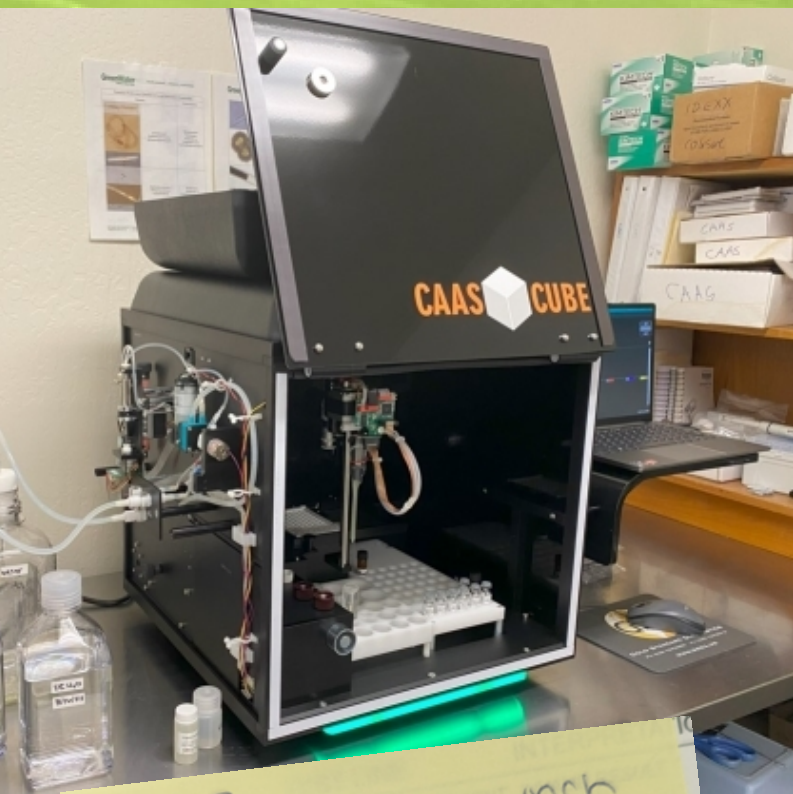
6/13/23
Del Valle Boat Launch
Mic Result = ND

Del Valle South end
Mic Result = ND

Quarry Lakes Swim Beach
Mic Result = 2.5 ppb

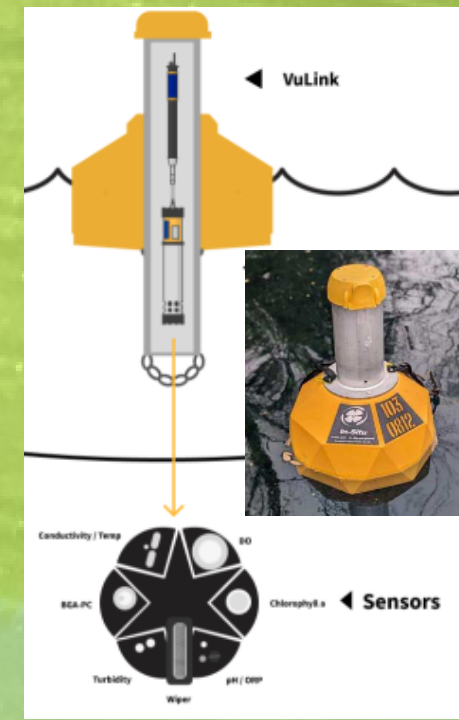
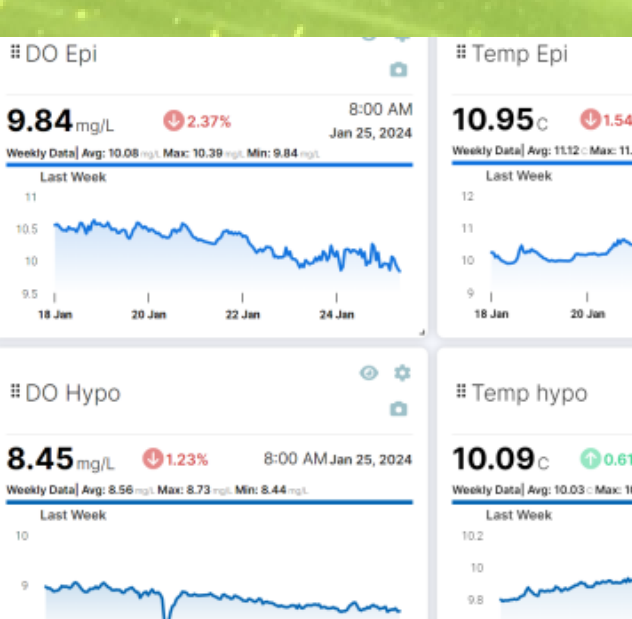
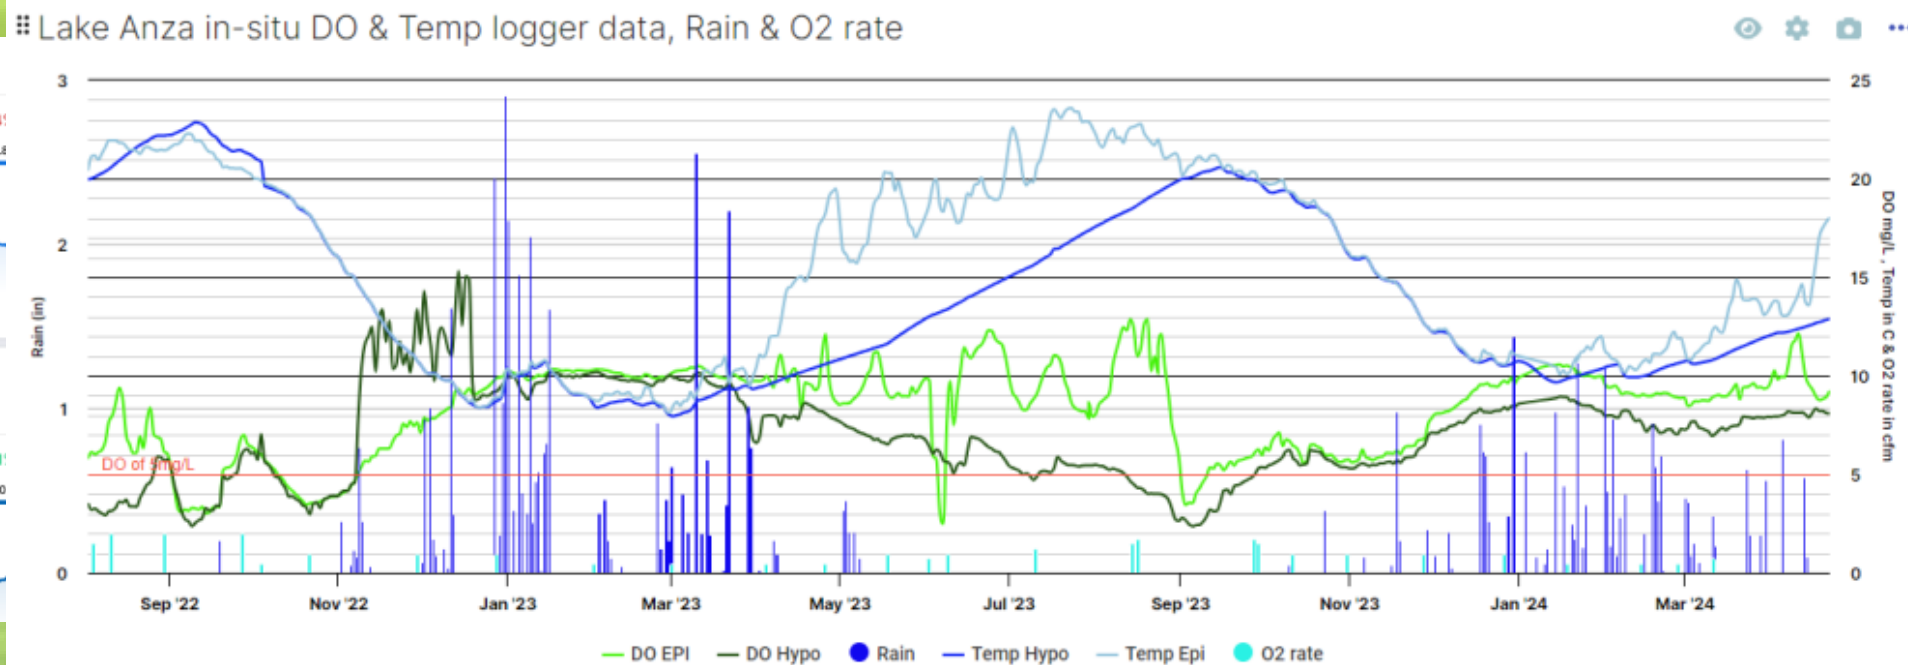
- Continuous temperature and dissolved oxygen monitoring through in-situ sensors
- Provides valuable information such as:
 - Lake mixing or stratification (thermal layers)
 - Is there oxygen at the lake bottom
 - Determine the amount of oxygen added to Lake Anza through the oxygenation system

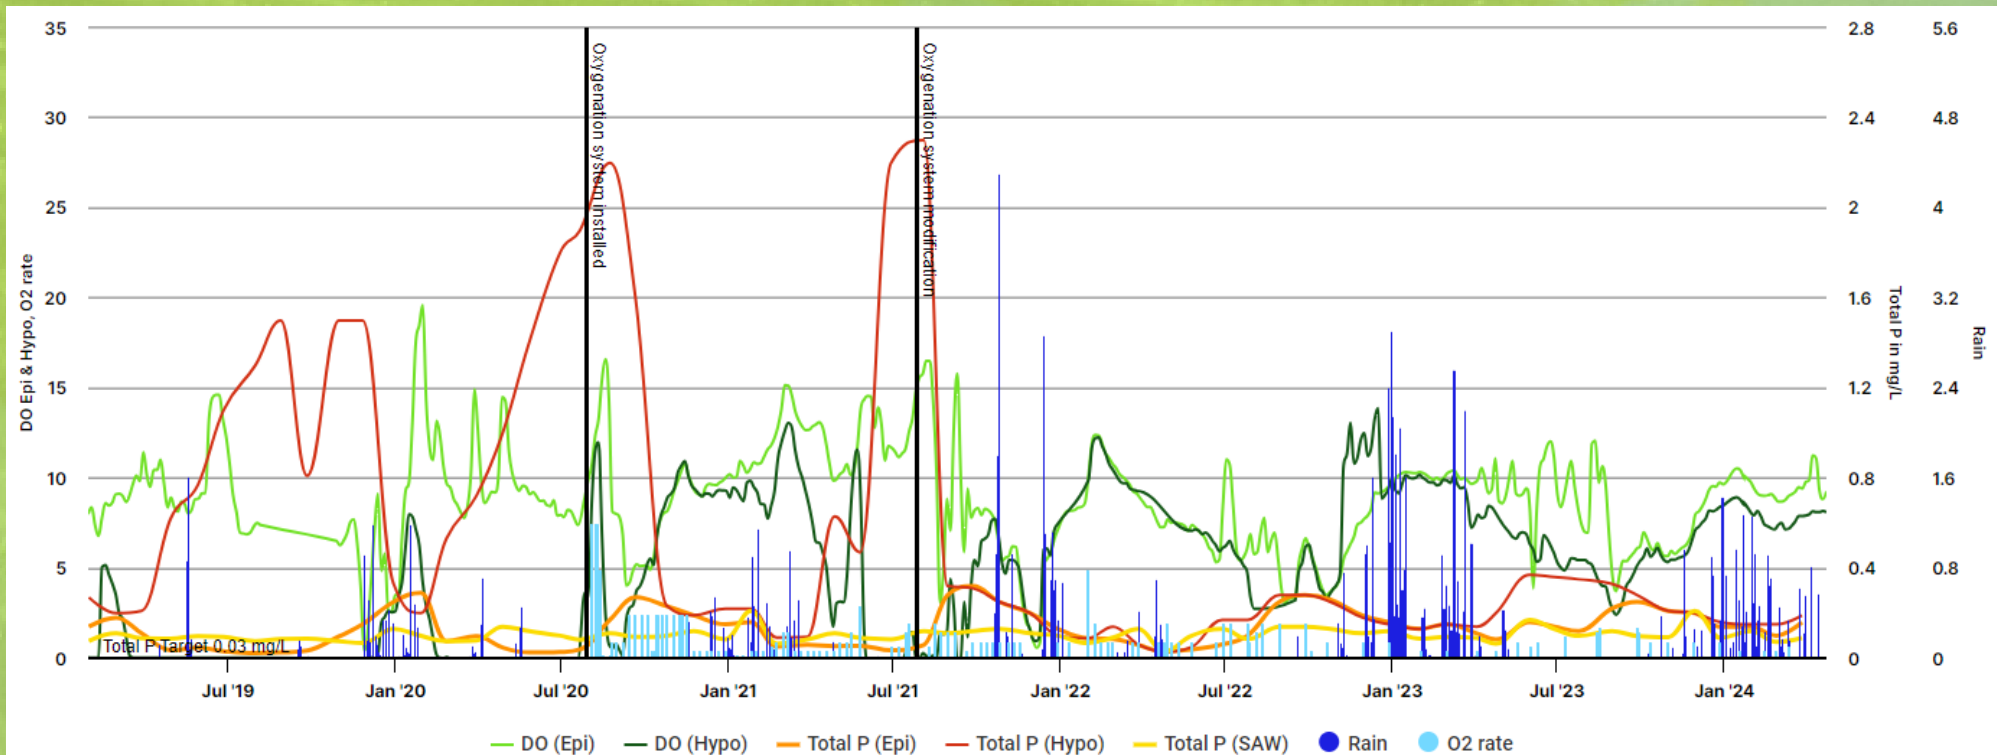
- Helpful tool to integrate past, current monitoring data and outside data (rain) into one platform
- Easy data management
- Nice graphs for presentations and reports
- Custom water quality parameter alerts

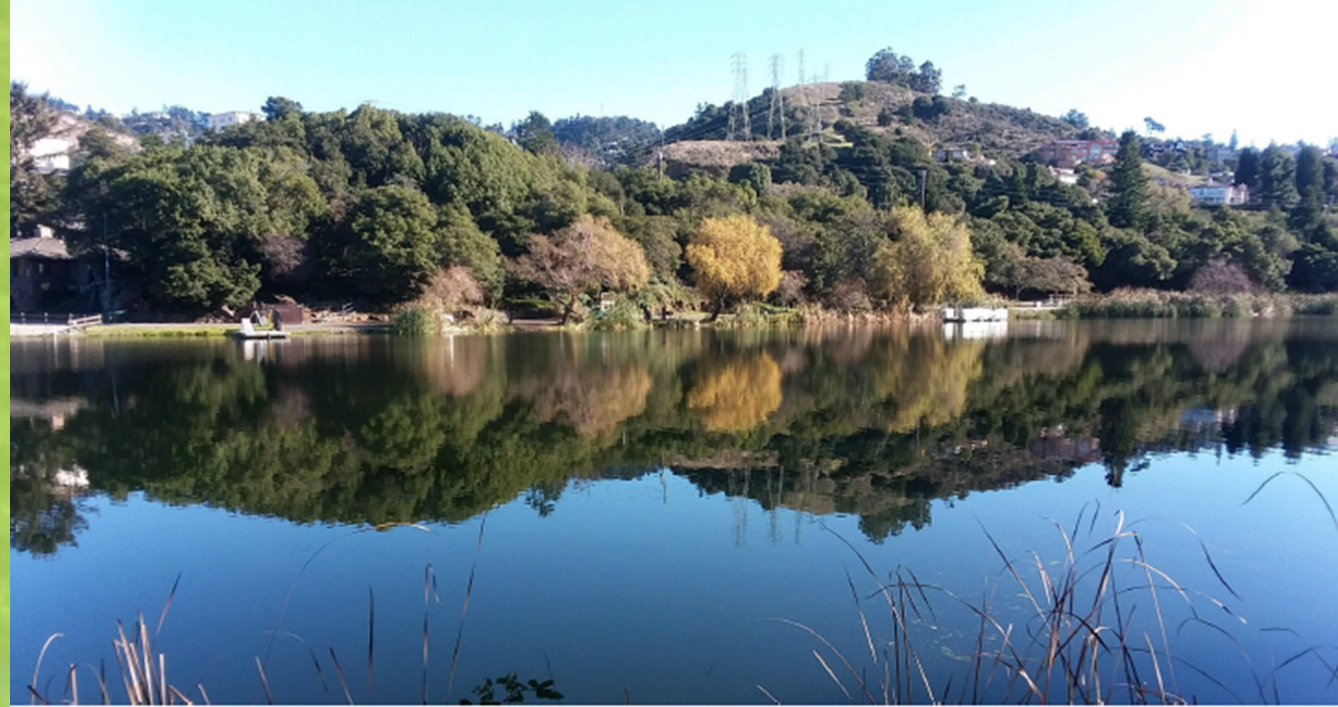
Lake Temescal Feasibility Study

Cost Estimate: \$25 – \$80 Million
